**Flood Control Project Maintenance  
Levee Inspections**  
**LMA District Cover Sheet**  
**Spring 2017 Levee Inspection Results**

**Reclamation District No. 0999 Netherlands**

**Spring 2017 Levee Inspection Results**

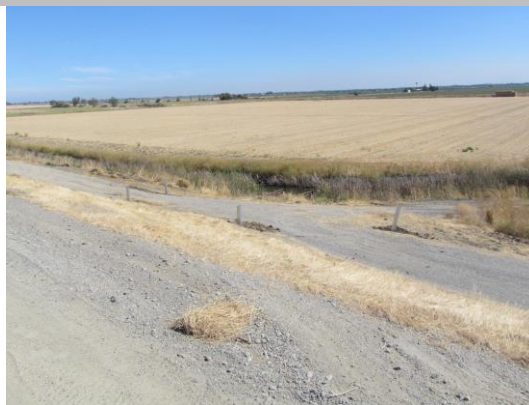
Photo 3 of 3 : SP\_2017\_RD0999\_232\_71\_20170314\_00082.jpg

LM Start	<b>12.28</b>	Rating **	U	Issue No.	<b>71 (cont)</b>
LM End	<b>12.28</b>	Issue Type +	En	Location *	CR

Looking east at gate and fence poles at landward berm.

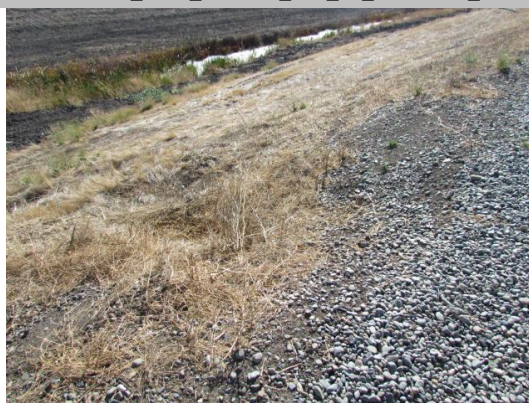
Photo 1 of 4 : SP\_2017\_RD0999\_232\_49\_20170314\_00051.jpg

LM Start	14.04	Rating **	M	Issue No.	49
LM End	14.04	Issue Type +	Ma	Location *	LS
Category	Earthen Levee			GPS Latitude/Longitude	
				Start	End
Item	Erosion / Bank Caving			38.310347 °	38.310347 °
				-121.644955 °	-121.644955 °
DWR ID	DWR_RD0999_01_f_2012_49				
Comment Code					
E1 : Note and monitor erosion site.					
Inspector Comment					
Caving, 4' x 10', on landside slope.

Looking southeast at caving on landward slope fall 2015.

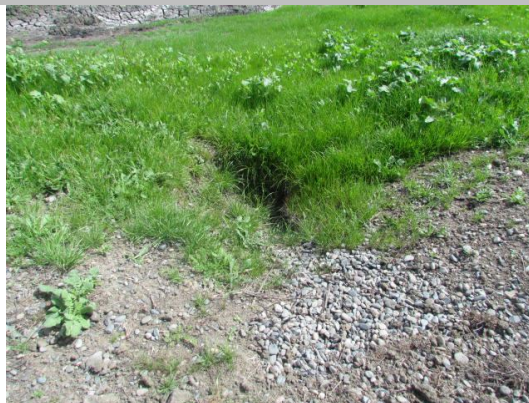
Photo 2 of 4 : SP\_2017\_RD0999\_232\_49\_20170314\_00052.jpg

LM Start	<b>14.04</b>	Rating **	M	Issue No.	<b>49 (cont)</b>
LM End	<b>14.04</b>	Issue Type +	Ma	Location *	LS

Looking east at caving on landward shoulder and slope. (Spring 2015)

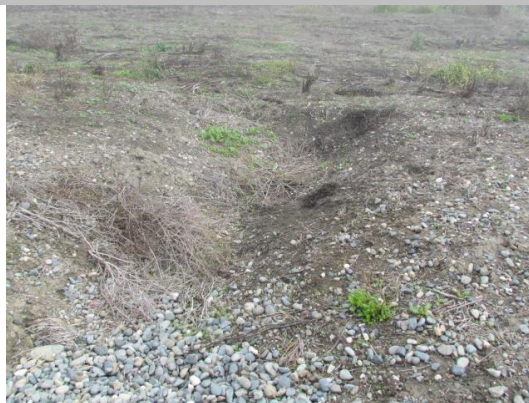
Photo 3 of 4 : SP\_2017\_RD0999\_232\_49\_20170314\_00053.jpg

LM Start	14.04	Rating **	M	Issue No.	49 (cont)	
LM End	14.04	Issue Type +	Ma	Location *	LS	
Category	Earthen Levee			GPS Latitude/Longitude		
				Start		End
Item	Erosion / Bank Caving			38.310347 °		38.310347 °
				-121.644955 °		-121.644955 °
DWR ID	DWR_RD0999_01_f_2012_49					
Comment Code						
E1 : Note and monitor erosion site.						
Inspector Comment						
Caving, 4' x 10', on landside slope.

Looking east caving on landside slope.

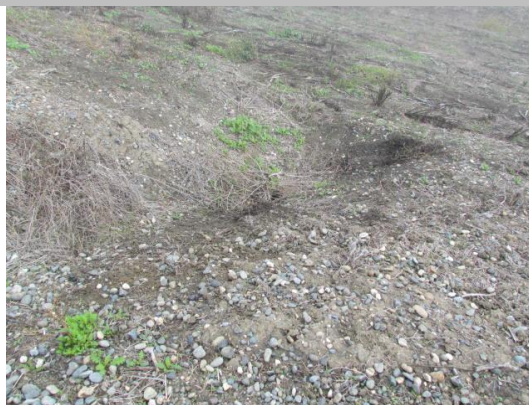
Photo 4 of 4 : SP\_2017\_RD0999\_232\_49\_20170314\_00054.jpg

LM Start	<b>14.04</b>	Rating **	M	Issue No.	<b>49 (cont)</b>
LM End	<b>14.04</b>	Issue Type +	Ma	Location *	LS

Looking southeast at caving on landside slope.

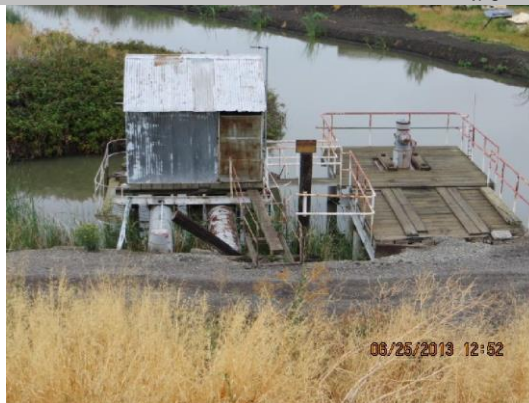
Photo 1 of 3 : UCIP\_SP\_2017\_15366\_25231.jpg

LM Start	15.24	Rating **	A/W	Issue No.	925
LM End	15.24	Issue Type +	Ma	Location *	CR
Category	Supplemental			GPS Latitude/Longitude	
				Start	End
Item	DWR UCIP LMA Responsibility			38.293005 °	38.293005 °
				-121.644974 °	-121.644974 °
DWR ID					
Comment Code					
Inspector Comment					
FS_ID:15366					
DS_ID:22757					
EP_NO: 14199					
Repair Type: No Action Needed					
Crossing Status: Found					
UCIP Comments:					
FIELD_STRUCT_DESC: 24-inch steel discharge pipe through the levee					
6.3 feet below the crown. Pumphouse on LS toe with a siphon breaker					
in a steel riser on WS shoulder (Permit No. 14199, 1985).					
FS Date: 6/25/2013

Pump in pumphouse on LS toe.

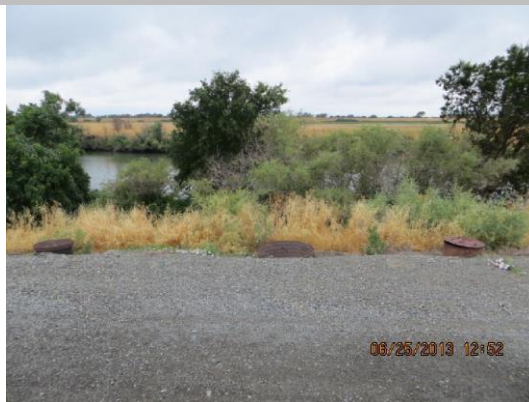
Photo 2 of 3 : UCIP\_SP\_2017\_15366\_25230.jpg

LM Start	<b>15.24</b>	Rating **	A/W	Issue No.	<b>925 (cont)</b>
LM End	<b>15.24</b>	Issue Type +	Ma	Location *	CR

siphon breaker in steel riser on WS shoulder

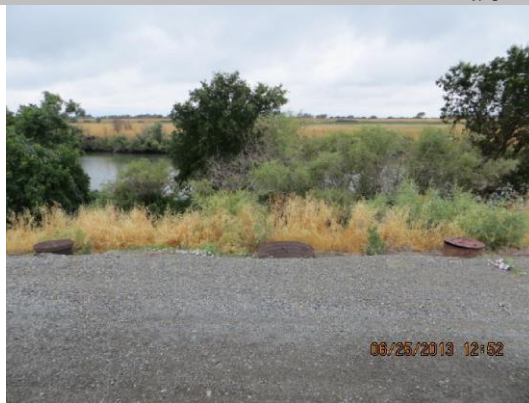
Photo 2 of 3 : UCIP\_SP\_2017\_15365\_25226.jpg

LM Start	15.24	Rating **	A/W	Issue No.	926 (cont)
LM End	15.24	Issue Type +	Ma	Location *	CR
Category	Supplemental			GPS Latitude/Longitude	
				Start	End
Item	DWR UCIP LMA Responsibility			38.292973 °	38.292973 °
				-121.644977 °	-121.644977 °
DWR ID					
Comment Code					
Inspector Comment					
FS_ID:15365					
DS_ID:22756					
EP_NO: N/A					
Repair Type: No Action Needed					
Crossing Status: Found					
UCIP Comments:					
FIELD_STRUCT_DESC: 30-inch pipe through the levee 7.0 feet below the crown. Flap gate on waterward end. Pump in pump house on landward toe. Siphon breaker in CMP riser on WS shoulder. Originally included in the 1966 O&M manual.					
FS Date: 6/25/2013

Siphon breaker in CMP riser on WS shoulder.

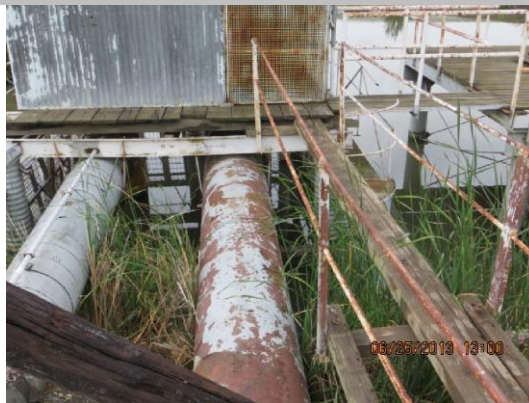
Photo 3 of 3 : UCIP\_SP\_2017\_15365\_25225.jpg

LM Start	<b>15.24</b>	Rating **	A/W	Issue No.	<b>926 (cont)</b>
LM End	<b>15.24</b>	Issue Type +	Ma	Location *	CR

Closeup of pipe at pump house on LS toe.

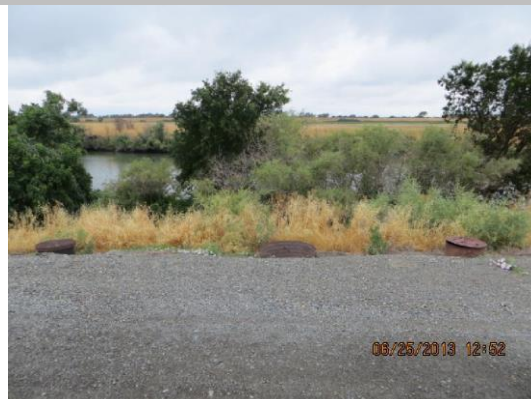
Photo 2 of 3 : UCIP\_SP\_2017\_15363\_25218.jpg

LM Start	<b>15.24</b>	Rating **	A/W	Issue No.	<b>927 (cont)</b>
LM End	<b>15.24</b>	Issue Type +	Ma	Location *	CR

Siphon breaker in CMP riser on WS shoulder.

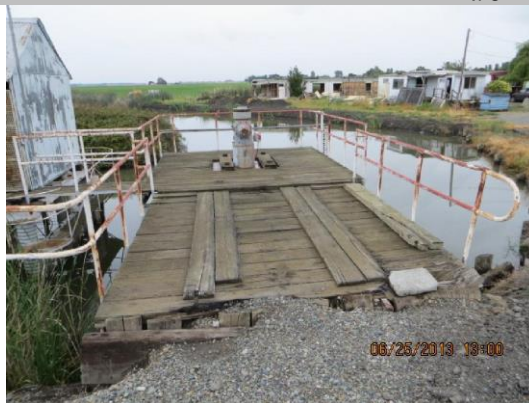
Photo 3 of 3 : UCIP\_SP\_2017\_15363\_25217.jpg

LM Start	15.24	Rating **	A/W	Issue No.	927 (cont)
LM End	15.24	Issue Type +	Ma	Location *	CR
Category	Supplemental			GPS Latitude/Longitude	
				Start	End
Item	DWR UCIP LMA Responsibility			38.292943 °	38.292943 °
				-121.644980 °	-121.644980 °
DWR ID					
Comment Code					
Inspector Comment					
FS_ID:15363 DS_ID:22755 EP_NO: 15303 Repair Type: No Action Needed Crossing Status: Found UCIP Comments: FIELD_STRUCT_DESC: 30-inch steel discharge pipe through the levee 7.0 feet below the crown. Pump on platform on landward toe, siphon breaker in CMP riser on waterward shoulder (Permit No. 15303, 1989). FS Date: 6/25/2013

Pump and platform on LS toe.

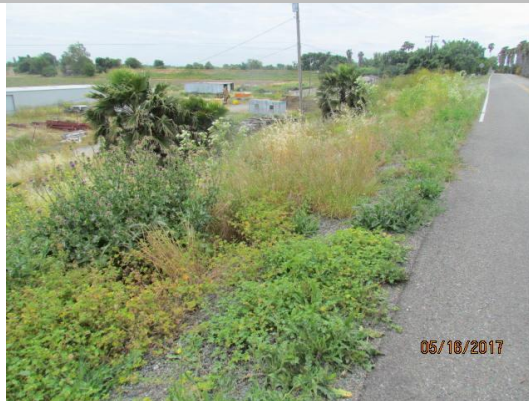
Photo 2 of 2 : SP\_2017\_RD0999\_232\_44\_20170516\_00116.jpg

LM Start	15.26	Rating **	U	Issue No.	44 (cont)	
LM End	15.26	Issue Type +	Ma	Location *	LS	
Category	Earthen Levee			GPS Latitude/Longitude		
				Start		End
Item	Vegetation			38.292702 °		38.292702 °
				-121.644967 °		-121.644967 °
DWR ID	DWR_RD0999_01_s_2016_44					
Comment Code						
V7 : Trees / Woody Vegetation						
Inspector Comment						
Unauthorized palm trees on landward slope and toe.

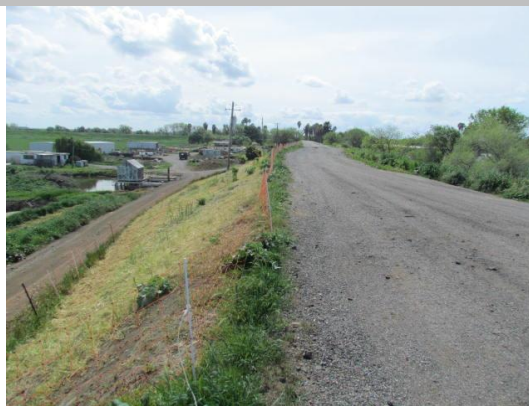
Photo 1 of 3 : SP\_2017\_RD0999\_232\_39\_20170314\_00034.jpg

LM Start	15.27	Rating **	M	Issue No.	39
LM End	15.41	Issue Type +	En	Location *	LS
Category	Earthen Levee			GPS Latitude/Longitude	
				Start	End
Item	Encroachments			38.292578 °	38.290525 °
				-121.644972 °	-121.644902 °
DWR ID	DWR_RD0999_01_s_2012_39				
Comment Code					
FE : Fence					
Inspector Comment					
Landowner has installed fence along landside slope for sheep to maintain levee slope. Landowner should apply for permit for fence. Landowner added additional fencing on landward shoulder and slope.

Looking east at new fencing on landward shoulder and slope. (Spring 2015)

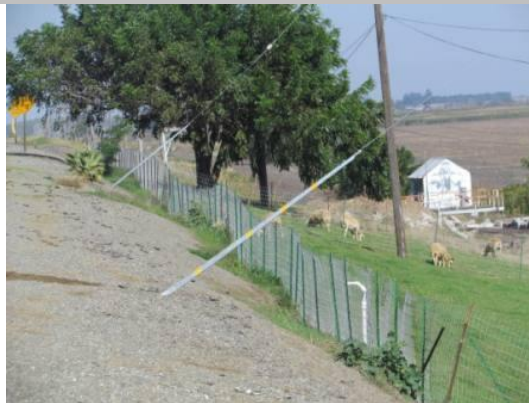
Photo 2 of 3 : SP\_2017\_RD0999\_232\_39\_20170314\_00035.jpg

Looking north at fence along landside slope.

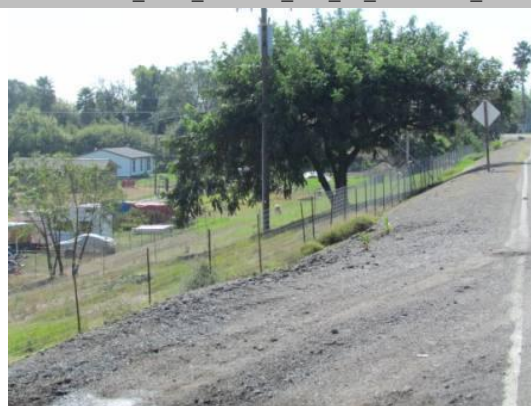
Photo 3 of 3 : SP\_2017\_RD0999\_232\_39\_20170314\_00036.jpg

LM Start	15.27	Rating **	M	Issue No.	39 (cont)	
LM End	15.41	Issue Type +	En	Location *	LS	
Category	Earthen Levee			GPS Latitude/Longitude		
				Start		End
Item	Encroachments			38.292578 °		38.290525 °
				-121.644972 °		-121.644902 °
DWR ID	DWR_RD0999_01_s_2012_39					
Comment Code						
FE : Fence						
Inspector Comment						
Landowner has installed fence along landside slope for sheep to maintain levee slope. Landowner should apply for permit for fence. Landowner added additional fencing on landward shoulder and slope.

Looking south at fence along landside slope.

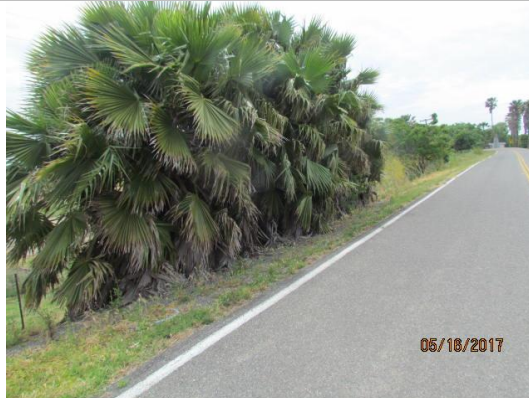
Photo 1 of 4 : SP\_2017\_RD0999\_232\_50\_20170516\_00117.jpg

LM Start	15.33	Rating **	U	Issue No.	50
LM End	15.33	Issue Type +	En	Location *	LS
Category	Earthen Levee			GPS Latitude/Longitude	
				Start	End
Item	Encroachments			38.291663 °	38.291663 °
				-121.644962 °	-121.644962 °
DWR ID	DWR_RD0999_01_f_2012_50				
Comment Code					
TR : Tree or limb					
Inspector Comment					
Planted palm trees on landside shoulder.

Looking east at palm trees (Spring 2017)

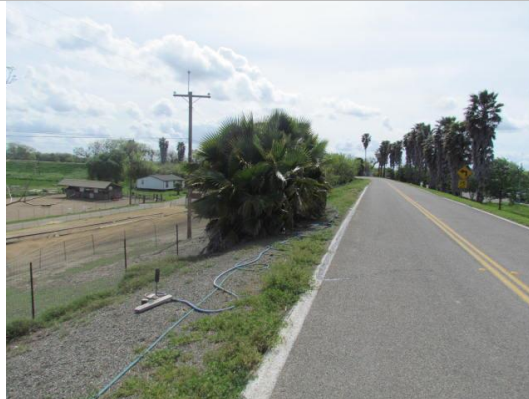
Photo 2 of 4 : SP\_2017\_RD0999\_232\_50\_20170314\_00055.jpg

Looking northeast at a mature palm trees on landward shoulder and slope. (Spring 2015)

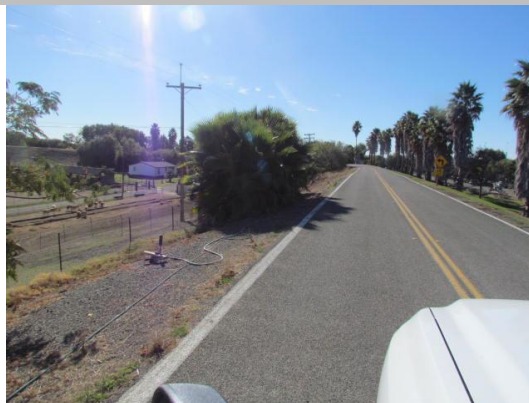
Photo 3 of 4 : SP\_2017\_RD0999\_232\_50\_20170314\_00056.jpg

LM Start	15.33	Rating **	U	Issue No.	50 (cont)	
LM End	15.33	Issue Type +	En	Location *	LS	
Category	Earthen Levee			GPS Latitude/Longitude		
				Start		End
Item	Encroachments			38.291663 °		38.291663 °
				-121.644962 °		-121.644962 °
DWR ID	DWR_RD0999_01_f_2012_50					
Comment Code						
TR : Tree or limb						
Inspector Comment						
Planted palm trees on landside shoulder.

Looking east at a maturing palm trees on landside shoulder and slope.  
(Fall 2014)

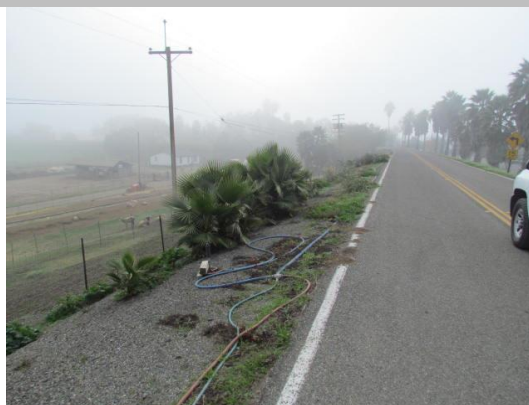
Photo 4 of 4 : SP\_2017\_RD0999\_232\_50\_20170314\_00057.jpg

Looking east at newly planted palm trees on landside shoulder and slope.

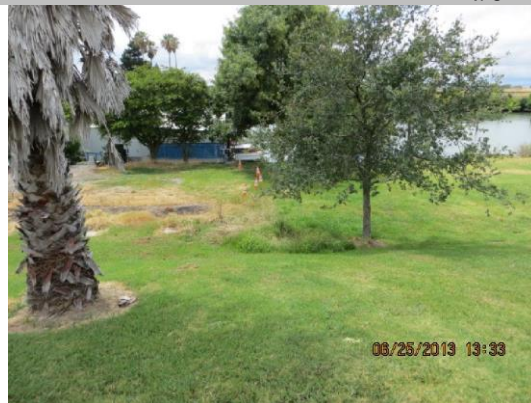
Photo 1 of 3 : UCIP\_SP\_2017\_16330\_27512.jpg

LM Start	15.36	Rating **	M	Issue No.	928
LM End	15.36	Issue Type +	En	Location *	LS
Category	Supplemental			GPS Latitude/Longitude	
				Start	End
Item	DWR UCIP Field Study			38.291192 °	38.291192 °
				-121.644987 °	-121.644987 °
DWR ID					
Comment Code					
Inspector Comment					
FS_ID:16330 DS_ID:23970 EP_NO: N/A Repair Type: Non-Urgent Crossing Status: Found UCIP Comments: No permit identified for this crossing. FIELD_STRUCT_DESC: 4-inch PVC waterline through the levee 2-feet below the crown. Pump off WS toe visible at waters edge. FS Date: 6/25/2013

Pipe visible at WS toe in grass.

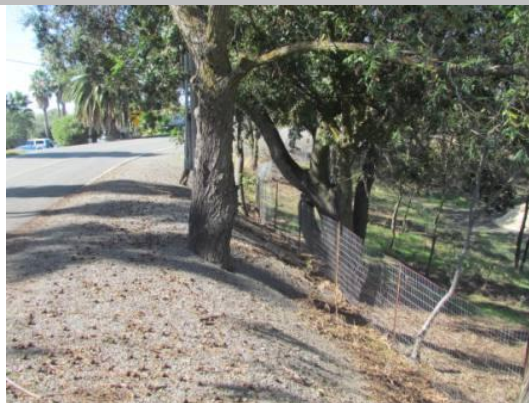
Photo 1 of 2 : SP\_2017\_RD0999\_233\_17\_20170314\_00019.jpg

LM Start	0.01	Rating **	M	Issue No.	17
LM End	0.06	Issue Type +	En	Location *	LS
Category	Earthen Levee			GPS Latitude/Longitude	
				Start	End
Item	Encroachments			38.290355 °	38.290472 °
				-121.644713 °	-121.643888 °
DWR ID	DWR_RD0999_02_s_2012_17				
Comment Code					
FE : Fence					
Inspector Comment					
Landowner has installed fence along landside slope for sheep to maintain levee slope. Landowner should apply for permit to keep fence.

Looking west at fence along landside slope.

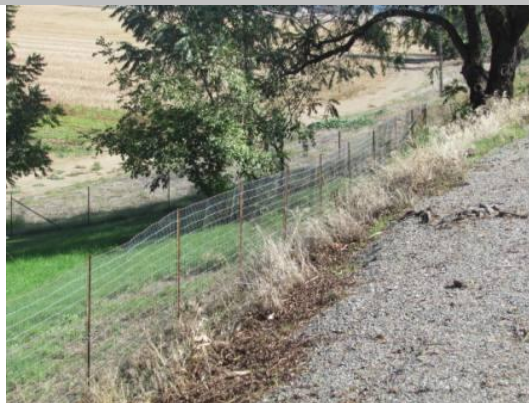
Photo 2 of 2 : SP\_2017\_RD0999\_233\_17\_20170314\_00020.jpg

LM Start	0.01	Rating **	M	Issue No.	17 (cont)	
LM End	0.06	Issue Type +	En	Location *	LS	
Category	Earthen Levee			GPS Latitude/Longitude		
				Start		End
Item	Encroachments			38.290355 °		38.290472 °
				-121.644713 °		-121.643888 °
DWR ID	DWR_RD0999_02_s_2012_17					
Comment Code						
FE : Fence						
Inspector Comment						
Landowner has installed fence along landside slope for sheep to maintain levee slope. Landowner should apply for permit to keep fence.

Looking northeast at fence along landside shoulder.

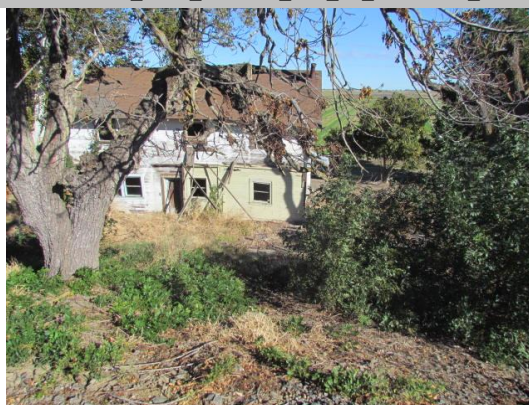
Photo 1 of 2 : SP\_2017\_RD0999\_233\_24\_20170314\_00025.jpg

LM Start	0.18	Rating **	U	Issue No.	24
LM End	0.18	Issue Type +	En	Location *	LS
Category	Earthen Levee			GPS Latitude/Longitude	
				Start	End
Item	Encroachments			38.290871 °	38.290871 °
				-121.641755 °	-121.641755 °
DWR ID	DWR_RD0999_02_f_2013_24				
Comment Code					
BU : Building					
Inspector Comment					
Adandoned building on landward toe and berm.

Looking southwest at abandoned building on landward berm.

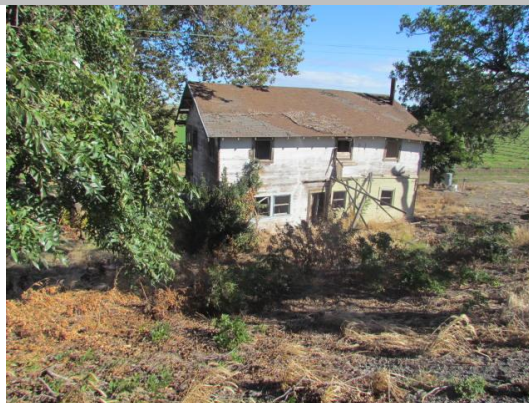
Photo 2 of 2 : SP\_2017\_RD0999\_233\_24\_20170314\_00026.jpg

Looking west at abandoned building on landward berm.

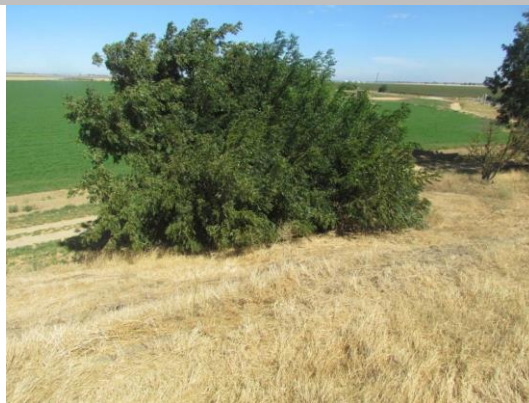
Photo 1 of 2 : SP\_2017\_RD0999\_233\_37\_20170314\_00029.jpg

Looking at untrimmed tree on landward slope and toe. (Fall 2016)

LM Start	0.73	Rating **	U	Issue No.	37
LM End	0.73	Issue Type +	Ma	Location *	LS
Category	Earthen Levee			GPS Latitude/Longitude	
				Start	End
Item	Trim / Thin Trees			38.292783 °	38.292783 °
				-121.632317 °	-121.632317 °
DWR ID	DWR_RD0999_02_s_2014_37				
Comment Code					
T1 : Trim trees to at least five feet above ground level.					
Inspector Comment

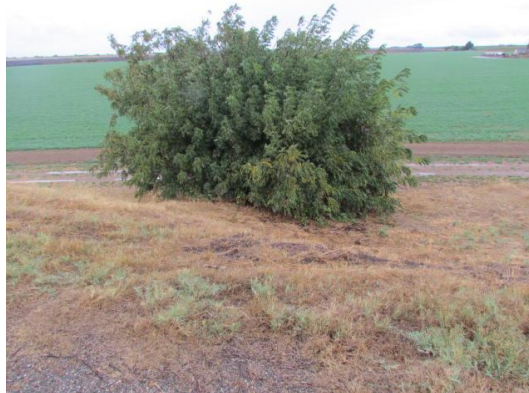
Photo 2 of 2 : SP\_2017\_RD0999\_233\_37\_20170314\_00030.jpg

Looking at untrimmed tree on landward slope. (Spring 2016)

LM Start	0.73	Rating **	U	Issue No.	37 (cont)	
LM End	0.73	Issue Type +	Ma	Location *	LS	
Category	Earthen Levee			GPS Latitude/Longitude		
				Start		End
Item	Trim / Thin Trees			38.292783 °		38.292783 °
				-121.632317 °		-121.632317 °
DWR ID	DWR_RD0999_02_s_2014_37					
Comment Code						
T1 : Trim trees to at least five feet above ground level.						
Inspector Comment

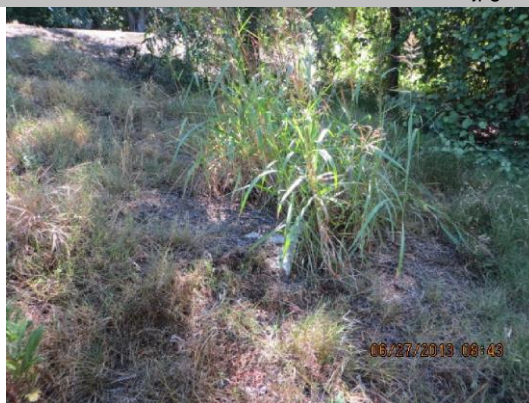
Photo 2 of 3 : UCIP\_SP\_2017\_15384\_25241.jpg

LM Start	0.79	Rating **	M	Issue No.	45
LM End	0.79	Issue Type +	En	Location *	WS
Category	Supplemental			GPS Latitude/Longitude	
				Start	End
Item	DWR UCIP Field Study			38.292562 °	38.292562 °
				-121.631331 °	-121.631331 °
DWR ID					
Comment Code					
Inspector Comment					
FS_ID:15384 DS_ID:22772 EP_NO: N/A Repair Type: Non-Urgent Crossing Status: Found UCIP Comments: Pipe open on both ends. Pumphouse has been removed. Needs to be abandoned properly. FIELD_STRUCT_DESC: *Abandoned* 8-inch pipe through levee 4.5 feet below crown. Abandoned pump house on the waterward slope. Originally included in the 1966 O&M manual. FS Date: 6/27/2013

Concrete pad on WS slope.

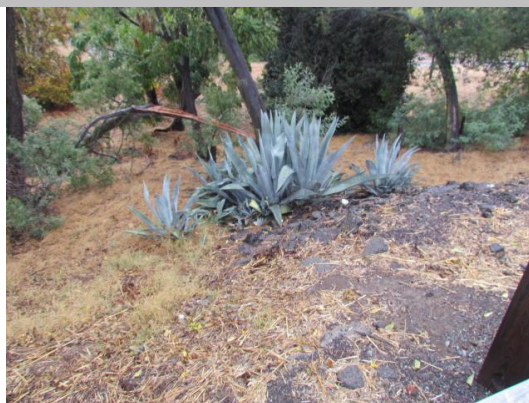
Photo 1 of 2 : SP\_2017\_RD0999\_233\_14\_20170314\_00015.jpg

LM Start	0.82	Rating **	U	Issue No.	14
LM End	0.82	Issue Type +	Ma	Location *	LS
Category	Earthen Levee			GPS Latitude/Longitude	
				Start	End
Item	Vegetation			38.292439 °	38.292439 °
				-121.630781 °	-121.630781 °
DWR ID	DWR_RD0999_02_f_2012_14				
Comment Code					
V2 : Remove the wild growth other than native grasses from the levee slopes.					
Inspector Comment					
Century plant on landside slope.

Looking north at century plant at landward toe fall 2015.

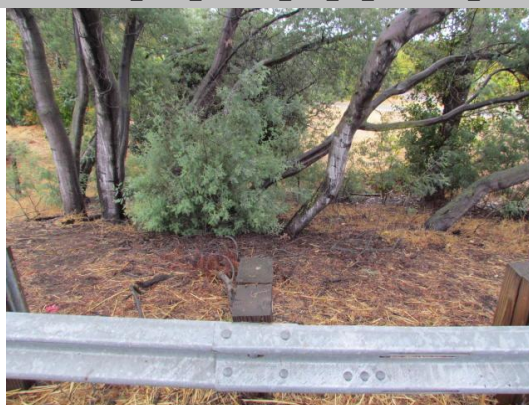
Photo 1 of 2 : SP\_2017\_RD0999\_233\_19\_20170314\_00021.jpg

Looking north at untrimmed trees to be thinned at landward toe fall 2015.

LM Start	0.83	Rating **	U	Issue No.	19
LM End	0.83	Issue Type +	Ma	Location *	LS
Category	Earthen Levee			GPS Latitude/Longitude	
				Start	End
Item	Trim / Thin Trees			38.292386 °	38.292386 °
				-121.630543 °	-121.630543 °
DWR ID	DWR_RD0999_02_f_2012_19				
Comment Code					
T2 : Thin trees to allow visibility of the ground and room to flood fight.					
Inspector Comment

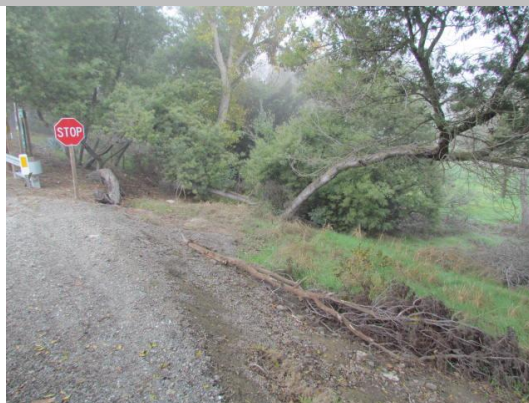
Photo 2 of 2 : SP\_2017\_RD0999\_233\_19\_20170314\_00022.jpg

Looking west at dense trees on landside slope and toe.

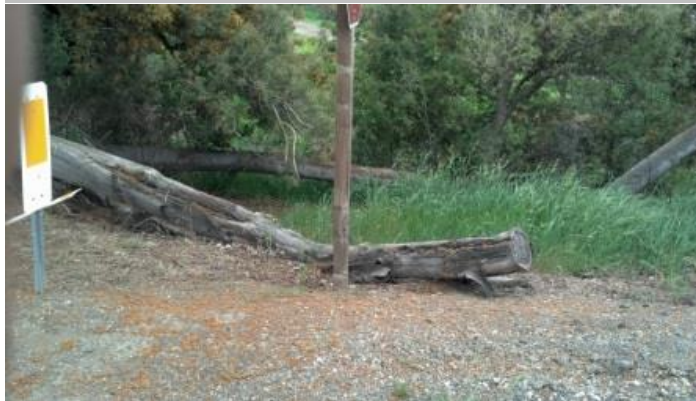
Photo 1 of 1 : SP\_2017\_RD0999\_233\_13\_20170314\_00014.jpg

LM Start	0.84	Rating **	M	Issue No.	13
LM End	0.84	Issue Type +	Ma	Location *	LS
Category	Earthen Levee			GPS Latitude/Longitude	
				Start	End
Item	Encroachments			38.292352 °	38.292352 °
				-121.630452 °	-121.630452 °
DWR ID	DWR_RD0999_02_s_2012_13				
Comment Code					
TR : Tree or limb					
Inspector Comment

Looking northwest at tree limb on landside slope.

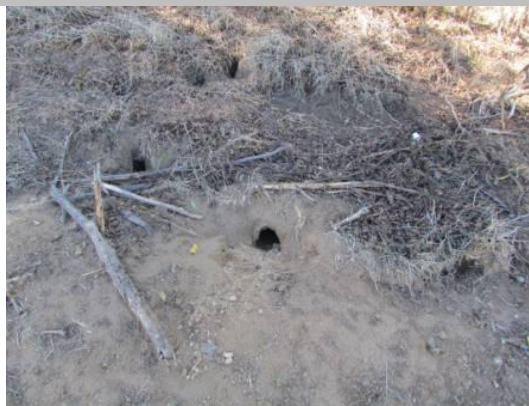
Photo 1 of 1 : SP\_2017\_RD0999\_233\_2\_20170314\_00004.jpg

LM Start	0.93	Rating **	M	Issue No.	2
LM End	1.03	Issue Type +	Ma	Location *	LS
Category	Earthen Levee			GPS Latitude/Longitude	
				Start	End
Item	Animal Control			38.291823 °	38.291250 °
				-121.628973 °	-121.627285 °
DWR ID	DWR_RD0999_02_s_2012_2				
Comment Code					
A1 : Exterminate rodents and backfill and compact or grout burrows.					
Inspector Comment

Looking at several rodent holes on landside slope.

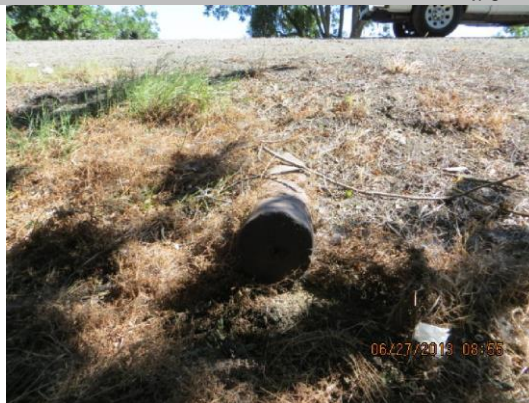
Photo 1 of 3 : UCIP\_SP\_2017\_15385\_25246.jpg

LM Start	0.93	Rating **	M	Issue No.	46
LM End	0.93	Issue Type +	En	Location *	LS
Category	Supplemental			GPS Latitude/Longitude	
				Start	End
Item	DWR UCIP Field Study			38.291739 °	38.291739 °
				-121.628873 °	-121.628873 °
DWR ID					
Comment Code					
Inspector Comment					
FS_ID:15385 DS_ID:22773 EP_NO: N/A Repair Type: Non-Urgent Crossing Status: Found UCIP Comments: Pipe should be abandoned properly. FIELD_STRUCT_DESC: *Abandoned* 10-inch steel irrigation pipe through levee 4.9 feet below crown. Capped on both ends. Originally included in the 1966 O&M manual. FS Date: 6/27/2013

Pipe with welded steel plate over end visible on WS

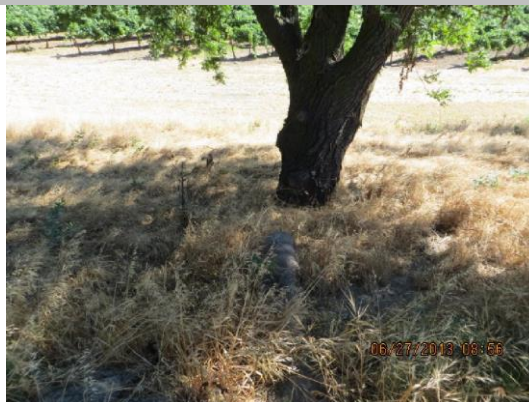
Photo 2 of 3 : UCIP\_SP\_2017\_15385\_25245.jpg

Pipe with welded steel plate over end visible on LS

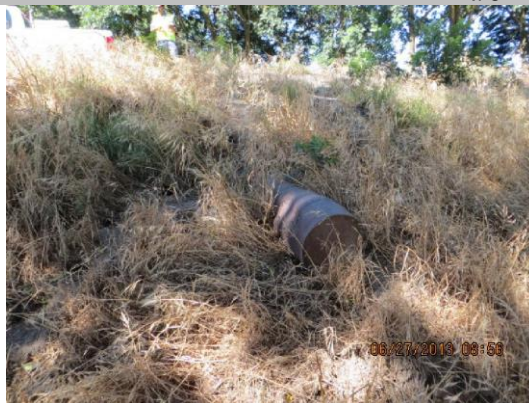
Photo 3 of 3 : UCIP\_SP\_2017\_15385\_25244.jpg

LM Start	0.93	Rating **	M	Issue No.	46 (cont)
LM End	0.93	Issue Type +	En	Location *	LS
Category	Supplemental			GPS Latitude/Longitude	
				Start	End
Item	DWR UCIP Field Study			38.291739 °	38.291739 °
				-121.628873 °	-121.628873 °
DWR ID					
Comment Code					
Inspector Comment					
FS_ID:15385 DS_ID:22773 EP_NO: N/A Repair Type: Non-Urgent Crossing Status: Found UCIP Comments: Pipe should be abandoned properly. FIELD_STRUCT_DESC: *Abandoned* 10-inch steel irrigation pipe through levee 4.9 feet below crown. Capped on both ends. Originally included in the 1966 O&M manual. FS Date: 6/27/2013

Pipe with welded steel plate over end

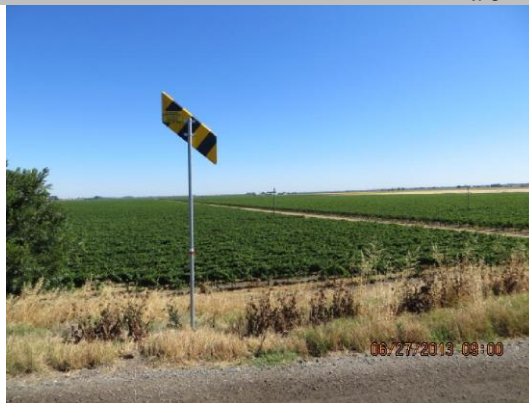
Photo 1 of 3 : UCIP\_SP\_2017\_16331\_27516.jpg

LM Start	1.02	Rating **	M	Issue No.	47
LM End	1.02	Issue Type +	En	Location *	LS
Category	Supplemental			GPS Latitude/Longitude	
				Start	End
Item	DWR UCIP Field Study			38.291252 °	38.291252 °
				-121.627398 °	-121.627398 °
DWR ID					
Comment Code					
Inspector Comment					
FS_ID:16331 DS_ID:23961 EP_NO: N/A Repair Type: Non-Urgent Crossing Status: Found UCIP Comments: Need to determine permit for this crossing. FIELD_STRUCT_DESC: Gasline through the levee at an unknown depth. Markers on both shoulders. FS Date: 6/27/2013

Gasline marker on LS shoulder.

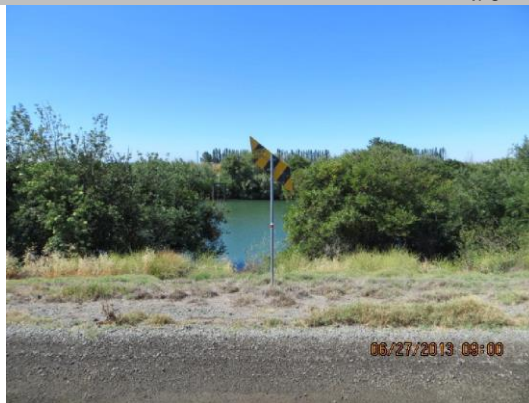
Photo 3 of 3 : UCIP\_SP\_2017\_16331\_27514.jpg

LM Start	1.02	Rating **	M	Issue No.	47 (cont)	
LM End	1.02	Issue Type +	En	Location *	LS	
Category	Supplemental			GPS Latitude/Longitude		
				Start		End
Item	DWR UCIP Field Study			38.291252 °		38.291252 °
				-121.627398 °		-121.627398 °
DWR ID						
Comment Code						
Inspector Comment						
FS_ID:16331 DS_ID:23961 EP_NO: N/A Repair Type: Non-Urgent Crossing Status: Found UCIP Comments: Need to determine permit for this crossing. FIELD_STRUCT_DESC: Gasline through the levee at an unknown depth. Markers on both shoulders. FS Date: 6/27/2013

Gasline marker on WS shoulder.

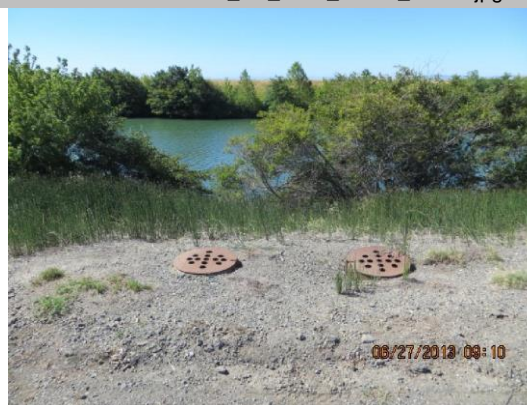
Photo 1 of 3 : UCIP\_SP\_2017\_16333\_27523.jpg

LM Start	1.25	Rating **	M	Issue No.	48
LM End	1.25	Issue Type +	En	Location *	WS
Category	Supplemental			GPS Latitude/Longitude	
				Start	End
Item	DWR UCIP Field Study			38.291379 °	38.291379 °
				-121.623285 °	-121.623285 °
DWR ID					
Comment Code					
Inspector Comment					
FS_ID:16333 DS_ID:23962 EP_NO: N/A Repair Type: Non-Urgent Crossing Status: Found UCIP Comments: Need to determine permit for this crossing. FIELD_STRUCT_DESC: 16-inch steel stormdrain through the levee 3- feet below the crown with a pump in a pumphouse on the LS toe. Siphon breaker in a 24-inch steel riser on WS. PN 17064, 1999. FS Date: 6/27/2013

Siphon breaker on WS shoulder.

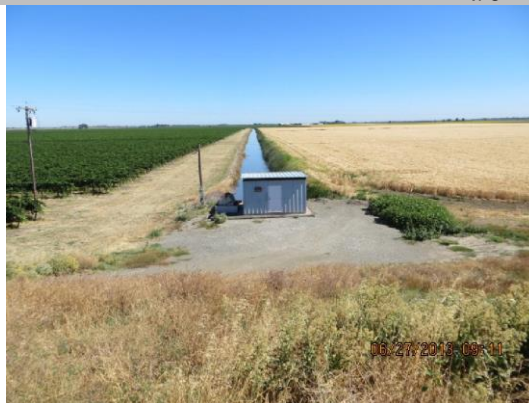
Photo 2 of 3 : UCIP\_SP\_2017\_16333\_27522.jpg

LM Start	1.25	Rating **	M	Issue No.	48 (cont)
LM End	1.25	Issue Type +	En	Location *	WS
Category	Supplemental			GPS Latitude/Longitude	
				Start	End
Item	DWR UCIP Field Study			38.291379 °	38.291379 °
				-121.623285 °	-121.623285 °
DWR ID					
Comment Code					
Inspector Comment					
FS_ID:16333 DS_ID:23962 EP_NO: N/A Repair Type: Non-Urgent Crossing Status: Found UCIP Comments: Need to determine permit for this crossing. FIELD_STRUCT_DESC: 16-inch steel stormdrain through the levee 3- feet below the crown with a pump in a pumphouse on the LS toe. Siphon breaker in a 24-inch steel riser on WS. PN 17064, 1999. FS Date: 6/27/2013

Pumphouse off LS toe.

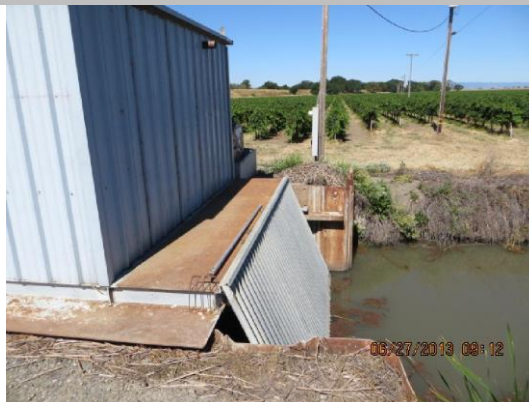
Photo 3 of 3 : UCIP\_SP\_2017\_16333\_27521.jpg

Trash rack on Pumphouse off LS toe.

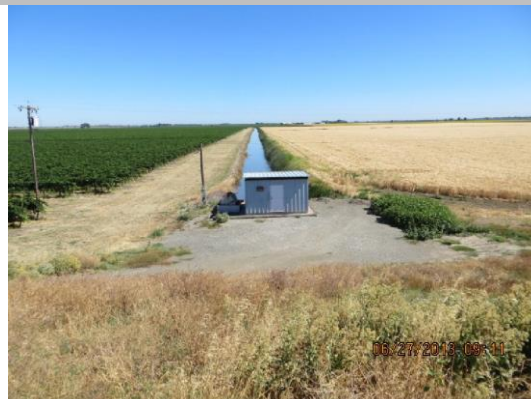
Photo 2 of 3 : UCIP\_SP\_2017\_16334\_27526.jpg

Pumphouse on LS toe.

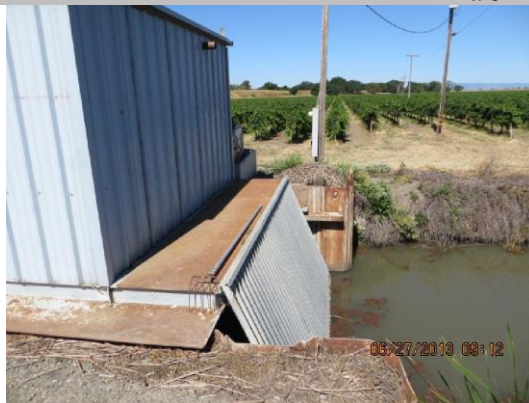
Photo 3 of 3 : UCIP\_SP\_2017\_16334\_27525.jpg

LM Start	1.25	Rating **	M	Issue No.	49 (cont)
LM End	1.25	Issue Type +	En	Location *	WS
Category	Supplemental			GPS Latitude/Longitude	
				Start	End
Item	DWR UCIP Field Study			38.291381 °	38.291381 °
				-121.623268 °	-121.623268 °
DWR ID					
Comment Code					
Inspector Comment					
FS_ID:16334					
DS_ID:23963					
EP_NO: N/A					
Repair Type: Non-Urgent					
Crossing Status: Found					
UCIP Comments: Need to determine permit No. for this crossing.					
FIELD_STRUCT_DESC: 30-inch steel stormdrain through the levee 2.5-					
feet below the crown with a pump in a pumphouse on the LS toe.					
Siphon breaker in a 24-inch steel riser on WS. Permit No. 17064, 1999					
FS Date: 6/27/2013

Pumphouse on LS toe with trash rack.

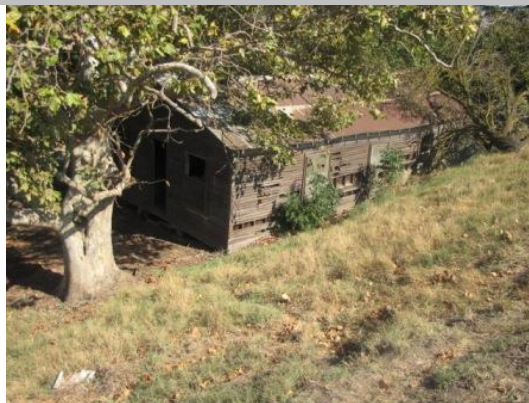
Photo 2 of 2 : SP\_2017\_RD0999\_233\_3\_20170314\_00006.jpg

LM Start	1.67	Rating **	U	Issue No.	3 (cont)	
LM End	1.68	Issue Type +	En	Location *	LS	
Category	Earthen Levee			GPS Latitude/Longitude		
				Start		End
Item	Encroachments			38.290287 °		38.290217 °
				-121.615668 °		-121.615460 °
DWR ID	DWR_RD0999_02_s_2012_3					
Comment Code						
BU : Building						
Inspector Comment						
Old abandoned storage shed on landward toe and berm.

Looking northeast at building at landside toe.

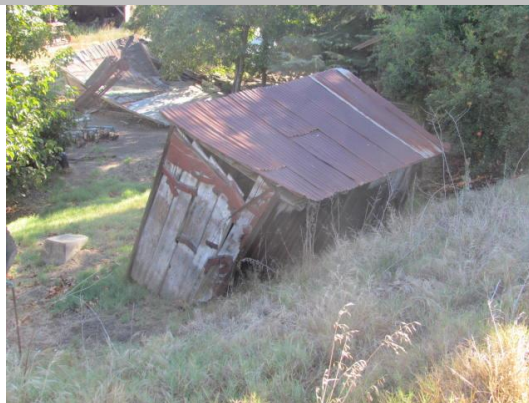
Photo 1 of 1 : SP\_2017\_RD0999\_233\_28\_20170314\_00027.jpg

LM Start	1.68	Rating **	U	Issue No.	28
LM End	1.68	Issue Type +	En	Location *	LS
Category	Earthen Levee			GPS Latitude/Longitude	
				Start	End
Item	Encroachments			38.290260 °	38.290260 °
				-121.615473 °	-121.615473 °
DWR ID	DWR_RD0999_02_f_2013_28				
Comment Code					
BU : Building					
Inspector Comment					
Abandoned pump house on landward toe.

Looking northeast at abandoned pump house on landward toe.

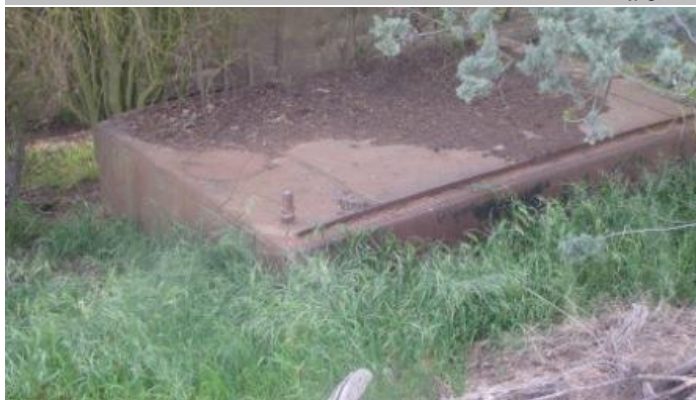
Photo 1 of 1 : SP\_2017\_RD0999\_233\_10\_20170314\_00011.jpg

LM Start	1.69	Rating **	U	Issue No.	10
LM End	1.69	Issue Type +	En	Location *	LS
Category	Earthen Levee			GPS Latitude/Longitude	
				Start	End
Item	Encroachments			38.290195 °	38.290195 °
				-121.615268 °	-121.615268 °
DWR ID	DWR_RD0999_02_s_2012_10				
Comment Code					
TA : Tank					
Inspector Comment

Looking north at a tank on the landside slope and toe.

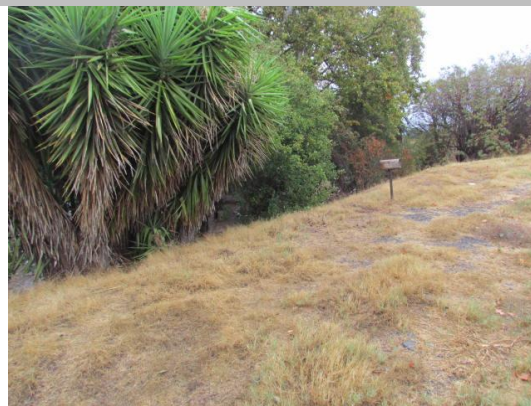
Photo 1 of 2 : SP\_2017\_RD0999\_233\_11\_20170314\_00012.jpg

LM Start	1.70	Rating **	U	Issue No.	11
LM End	1.70	Issue Type +	En	Location *	LS
Category	Earthen Levee			GPS Latitude/Longitude	
				Start	End
Item	Vegetation			38.290171 °	38.290171 °
				-121.615260 °	-121.615260 °
DWR ID	DWR_RD0999_02_s_2012_11				
Comment Code					
V6 : Landscaping					
Inspector Comment

Looking at dense trees on landward slope.

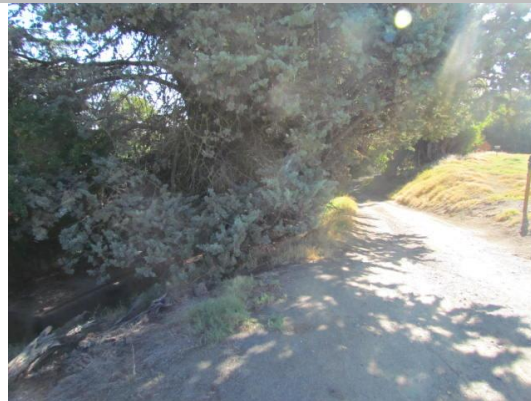
Photo 2 of 2 : SP\_2017\_RD0999\_233\_11\_20170314\_00013.jpg

Looking southwest at dense trees on landward slope.

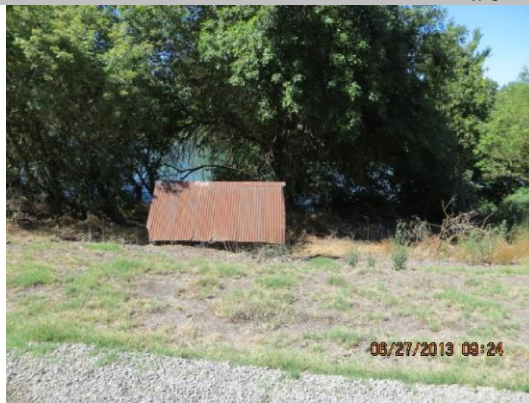
Photo 1 of 3 : UCIP\_SP\_2017\_15386\_25249.jpg

FS\_ID:15386  
DS\_ID:22774  
EP\_NO: N/A  
Repair Type: Non-Urgent  
Crossing Status: Found  
UCIP Comments: Pipe abandoned and should be done so properly.  
FIELD\_STRUCT\_DESC: \*ABANDONED\* 10-inch pipe through levee 8.3 feet below crown. 6'X11' corrugated metal Pump house and gate valve on the waterward slope. 36-inch concrete standpipe on LS toe. Originally included in the 1966 O&M manual.  
FS Date: 6/27/2013

Pumphouse on WS slope.

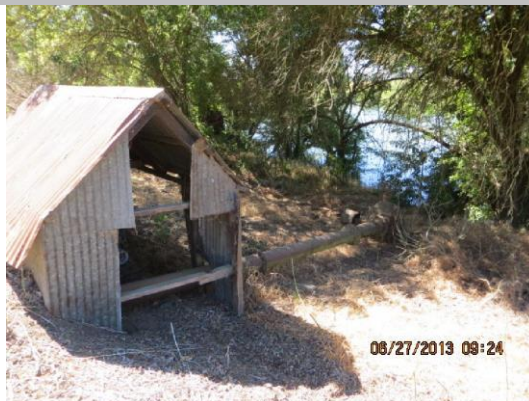
Photo 2 of 3 : UCIP\_SP\_2017\_15386\_25248.jpg

Pipe, pumphouse, and gate valve on WS slope.

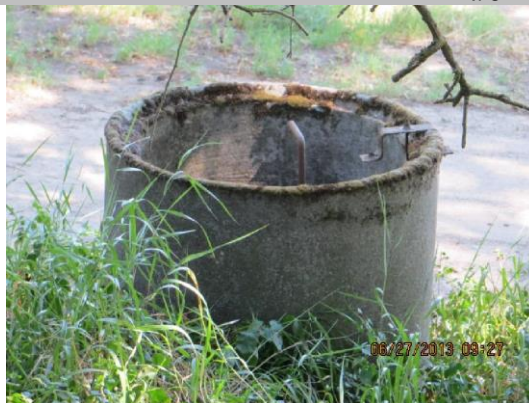
Photo 3 of 3 : UCIP\_SP\_2017\_15386\_25247.jpg

LM Start	1.72	Rating **	M	Issue No.	50 (cont)	
LM End	1.72	Issue Type +	En	Location *	LS	
Category	Supplemental			GPS Latitude/Longitude		
				Start	End	
Item	DWR UCIP Field Study			38.289967 °	38.289967 °	
				-121.614873 °	-121.614873 °	
DWR ID						
Comment Code						
Inspector Comment						
FS_ID:15386						
DS_ID:22774						
EP_NO: N/A						
Repair Type: Non-Urgent						
Crossing Status: Found						
UCIP Comments: Pipe abandoned and should be done so properly.						
FIELD_STRUCT_DESC: *ABANDONED* 10-inch pipe through levee						
8.3 feet below crown. 6'X11' corrugated metal Pump house and gate						
valve on the waterward slope. 36-inch concrete standpipe on LS toe.						
Originally included in the 1966 O&M manual.						
FS Date: 6/27/2013

Concrete standpipe on LS toe.

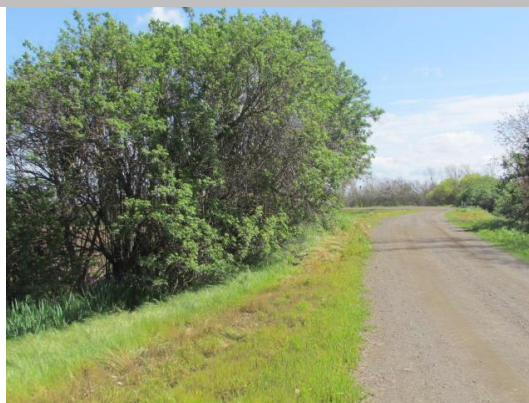
Photo 1 of 3 : SP\_2017\_RD0999\_233\_8\_20170314\_00008.jpg

LM Start	1.73	Rating **	A/W	Issue No.	8
LM End	1.76	Issue Type +	Ma	Location *	LS
Category	Earthen Levee			GPS Latitude/Longitude	
				Start	End
Item	Vegetation			38.289895 °	38.289595 °
				-121.614688 °	-121.614337 °
DWR ID	DWR_RD0999_02_s_2012_8				
Comment Code					
V2 : Remove the wild growth other than native grasses from the levee slopes.					
Inspector Comment

Looking east at dense vegetation on landward shoulder and slope.  
(Spring 2016)

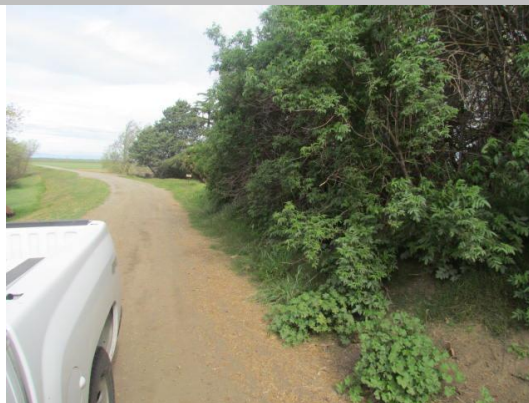
Photo 2 of 3 : SP\_2017\_RD0999\_233\_8\_20170314\_00009.jpg

LM Start	1.73	Rating **	A/W	Issue No.	8 (cont)	
LM End	1.76	Issue Type +	Ma	Location *	LS	
Category	Earthen Levee			GPS Latitude/Longitude		
				Start		End
Item	Vegetation			38.289895 °		38.289595 °
				-121.614688 °		-121.614337 °
DWR ID	DWR_RD0999_02_s_2012_8					
Comment Code						
V2 : Remove the wild growth other than native grasses from the levee slopes.						
Inspector Comment

Looking west at dense vegetation on landward shoulder and slope.  
(Spring 2015)

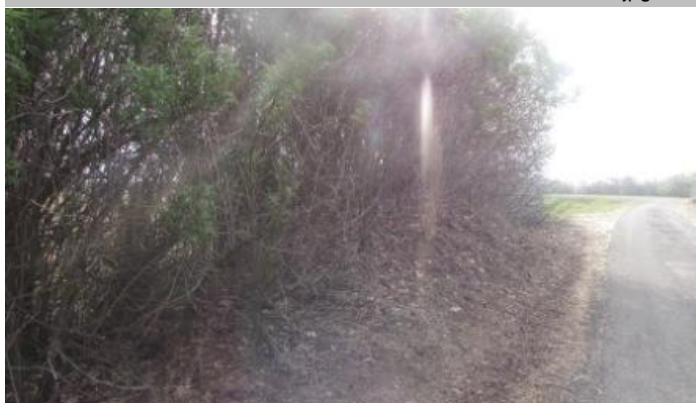
Photo 3 of 3 : SP\_2017\_RD0999\_233\_8\_20170314\_00010.jpg

Looking east at elderberry bush on landside shoulder and slope. (Fall 2014)

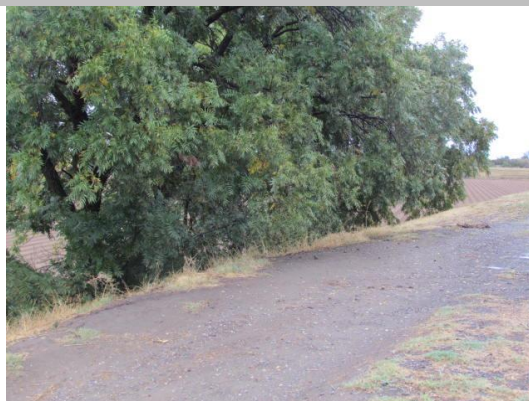
Photo 1 of 1 : SP\_2017\_RD0999\_233\_29\_20170314\_00028.jpg

LM Start	2.06	Rating **	U	Issue No.	29
LM End	2.07	Issue Type +	Ma	Location *	LS
Category	Earthen Levee			GPS Latitude/Longitude	
				Start	End
Item	Trim / Thin Trees			38.288870 °	38.288844 °
				-121.609259 °	-121.609008 °
DWR ID	DWR_RD0999_02_f_2013_29				
Comment Code					
T1 : Trim trees to at least five feet above ground level.					
Inspector Comment

Looking at untrimmed trees on landward slope fall 2015.

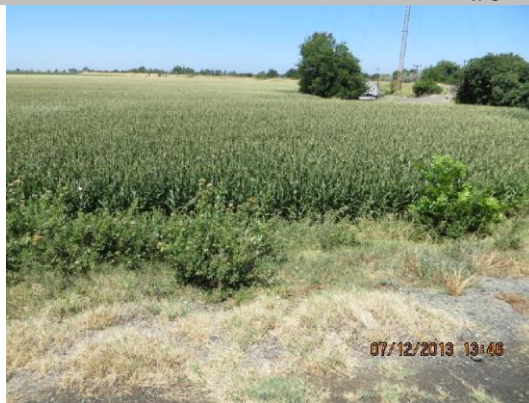
Photo 1 of 3 : UCIP\_SP\_2017\_15703\_26125.jpg

LM Start	2.28	Rating **	M	Issue No.	52
LM End	2.28	Issue Type +	En	Location *	LS
Category	Supplemental			GPS Latitude/Longitude	
				Start	End
Item	DWR UCIP Field Study			38.286666 °	38.286666 °
				-121.606803 °	-121.606803 °
DWR ID					
Comment Code					
Inspector Comment					
FS_ID:15703 DS_ID:22770 EP_NO: 3855 Repair Type: Non-Urgent Crossing Status: Found UCIP Comments: Pipe not capped on LS and not found on WS. FIELD_STRUCT_DESC: 10-inch steel irrigation pipe through the levee 4.0 feet below the crown. Capped during winter months. 6-inch pipe sleeved through 10-inch during irrigation season (Permit No. 3855, 1962). Included in the 1966 O&M manual. FS Date: 6/27/2013

Pipe visible just off shoulder on LS slope in the rose bushes.

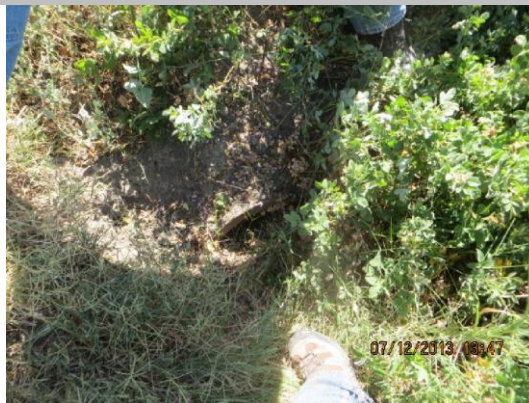
Photo 2 of 3 : UCIP\_SP\_2017\_15703\_26124.jpg

Pipe visible just off shoulder on LS slope in the rose bushes.

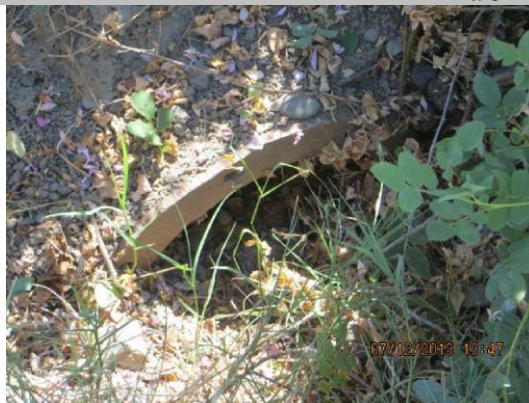
Photo 3 of 3 : UCIP\_SP\_2017\_15703\_26123.jpg

LM Start	2.28	Rating **	M	Issue No.	52 (cont)	
LM End	2.28	Issue Type +	En	Location *	LS	
Category	Supplemental			GPS Latitude/Longitude		
				Start	End	
Item	DWR UCIP Field Study			38.286666 °	38.286666 °	
				-121.606803 °	-121.606803 °	
DWR ID						
Comment Code						
Inspector Comment						
FS_ID:15703 DS_ID:22770 EP_NO: 3855 Repair Type: Non-Urgent Crossing Status: Found UCIP Comments: Pipe not capped on LS and not found on WS. FIELD_STRUCT_DESC: 10-inch steel irrigation pipe through the levee 4.0 feet below the crown. Capped during winter months. 6-inch pipe sleeved through 10-inch during irrigation season (Permit No. 3855, 1962). Included in the 1966 O&M manual. FS Date: 6/27/2013

Pipe partially filled with soil and open on LS.

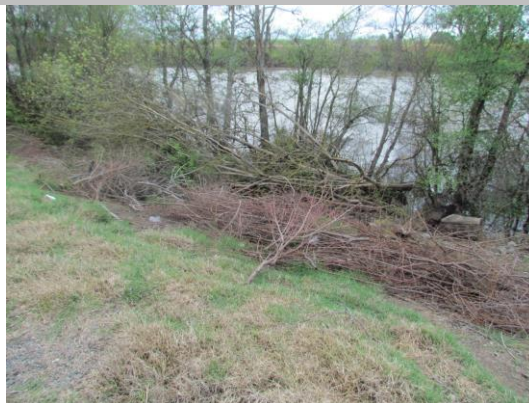
Photo 1 of 1 : SP\_2017\_RD0999\_234\_23\_20170324\_00043.jpg

LM Start	0.09	Rating **	M	Issue No.	23
LM End	0.09	Issue Type +	Ma	Location *	WS
Category	Earthen Levee			GPS Latitude/Longitude	
				Start	End
Item	Encroachments			38.287595 °	38.287595 °
				-121.605275 °	-121.605275 °
DWR ID	DWR_RD0999_03_s_2017_23				
Comment Code					
PR : Prunings					
Inspector Comment					
Large pruning piles on waterward slope.

Looking east large pruning piles on waterward slope.

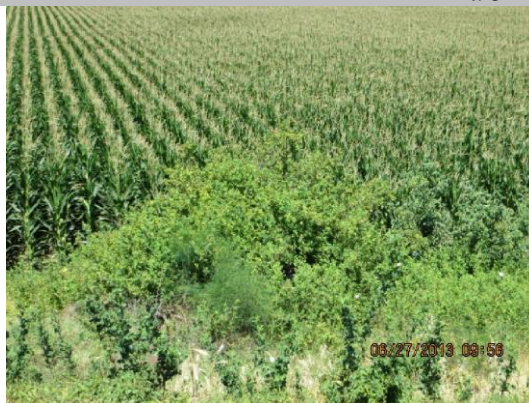
Photo 1 of 3 : UCIP\_SP\_2017\_15389\_25254.jpg

LM Start	0.18	Rating **	M	Issue No.	51
LM End	0.18	Issue Type +	En	Location *	WS
Category	Supplemental			GPS Latitude/Longitude	
				Start	End
Item	DWR UCIP Field Study			38.288813 °	38.288813 °
				-121.604670 °	-121.604670 °
DWR ID					
Comment Code					
Inspector Comment					
FS_ID:15389 DS_ID:22776 EP_NO: N/A Repair Type: Non-Urgent Crossing Status: Found UCIP Comments: Pipe abandoned and should be done so properly. FIELD_STRUCT_DESC: *Abandoned* 10-inch pipe through levee 6.2 feet below crown. Abandoned 4'X7' concrete pumphouse and gate valve on the landward slope. Plate welded on the waterward end. Originally included in the 1966 O&M manual. FS Date: 6/27/2013

Pumphouse on LS slope covered in rose bush.

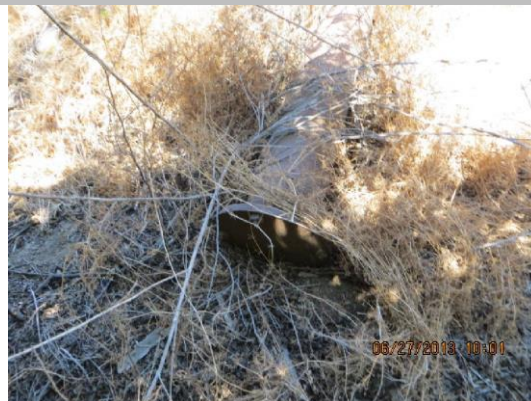
Photo 3 of 3 : UCIP\_SP\_2017\_15389\_25252.jpg

LM Start	0.18	Rating **	M	Issue No.	51 (cont)	
LM End	0.18	Issue Type +	En	Location *	WS	
Category	Supplemental			GPS Latitude/Longitude		
				Start	End	
Item	DWR UCIP Field Study			38.288813 °	38.288813 °	
				-121.604670 °	-121.604670 °	
DWR ID						
Comment Code						
Inspector Comment						
FS_ID:15389 DS_ID:22776 EP_NO: N/A Repair Type: Non-Urgent Crossing Status: Found UCIP Comments: Pipe abandoned and should be done so properly. FIELD_STRUCT_DESC: *Abandoned* 10-inch pipe through levee 6.2 feet below crown. Abandoned 4'X7' concrete pumphouse and gate valve on the landward slope. Plate welded on the waterward end. Originally included in the 1966 O&M manual. FS Date: 6/27/2013

Steel plate on WS end of pipe.

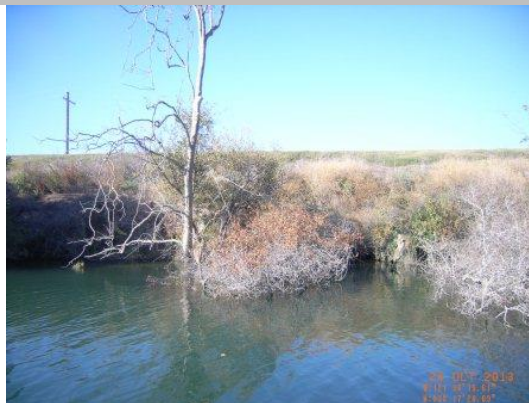
Photo 1 of 1 : SP\_2017\_RD0999\_234\_29\_20170314\_00024.jpg

Comment Code					
Inspector Comment					
1997 - Intermittent over-steepened sections. Large riparian vegetation along the length of the entire reach. Attempts to repair with rock on bank have failed. 1999 - New rock repair at the downstream end. 2002 - Some minor spot repairs. 2009 - Minimal new erosion. 2010 - Appears that fresh rock placed on downstream portion of site. Toe scour and overhanging trees with some overturned. 2012 - Minor new erosion at the toe. 2013 - Site upgraded to CRITICAL. Severe slumping into levee at downstream end of site. Fresh erosion into bank toe. 2015: New slumping, tall vertical sections. [2015 Site ID: STR_24-7_R]

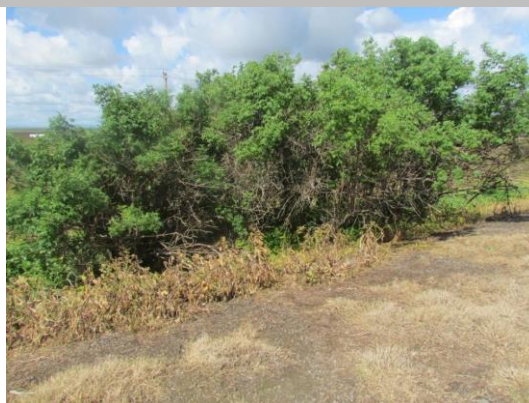
Photo 1 of 3 : SP\_2017\_RD0999\_234\_8\_20170324\_00044.jpg

LM Start	0.66	Rating **	U	Issue No.	8
LM End	0.66	Issue Type +	Ma	Location *	LS
Category	Earthen Levee			GPS Latitude/Longitude	
				Start	End
Item	Vegetation			38.295618 °	38.295618 °
				-121.605923 °	-121.605923 °
DWR ID	DWR_RD0999_03_s_2012_8				
Comment Code					
V4 : Elderberries are blocking visibility and flood fight capability.					
Inspector Comment					
Dense veg on landward slope.

Looking east at dense veg on landward slope. (Spring 2017)

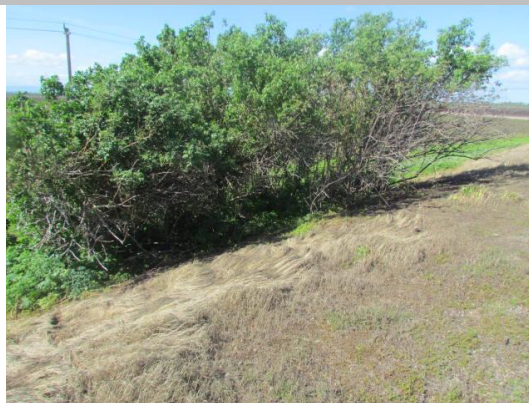
Photo 2 of 3 : SP\_2017\_RD0999\_234\_8\_20170314\_00006.jpg

Looking east at elderberry at landward slope and toe. (Spring 2016)

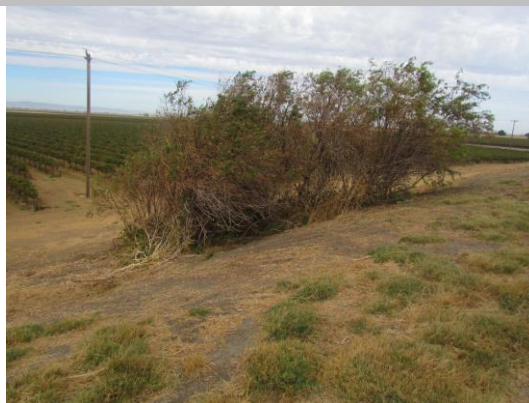
Photo 3 of 3 : SP\_2017\_RD0999\_234\_8\_20170314\_00005.jpg

Looking east at brush on landward slope and toe. (Fall 2016)

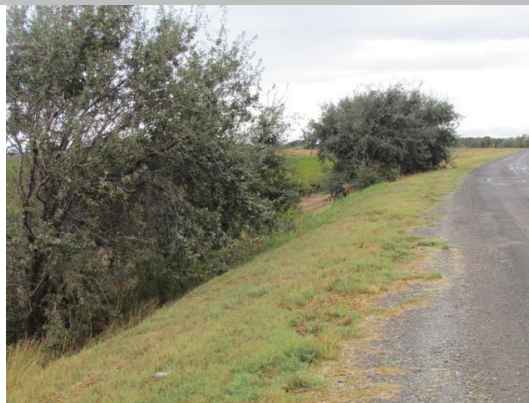
Photo 1 of 1 : SP\_2017\_RD0999\_234\_43\_20170314\_00028.jpg

LM Start	0.93	Rating **	U	Issue No.	43
LM End	0.95	Issue Type +	Ma	Location *	LS
Category	Earthen Levee			GPS Latitude/Longitude	
				Start	End
Item	Trim / Thin Trees			38.299130 °	38.299362 °
				-121.603768 °	-121.603462 °
DWR ID	DWR_RD0999_03_f_2014_43				
Comment Code					
T1 : Trim trees to at least five feet above ground level.					
Inspector Comment

Looking at untrimmed trees on landward slope and toe.
